**An Ecological Survey
of
Beaminster bridleway Buckham Down Farm to The Old Cheese
House W21/80**

**prepared on behalf of Dorset Council
by Ali Quinney, Ecologist**

April 2023

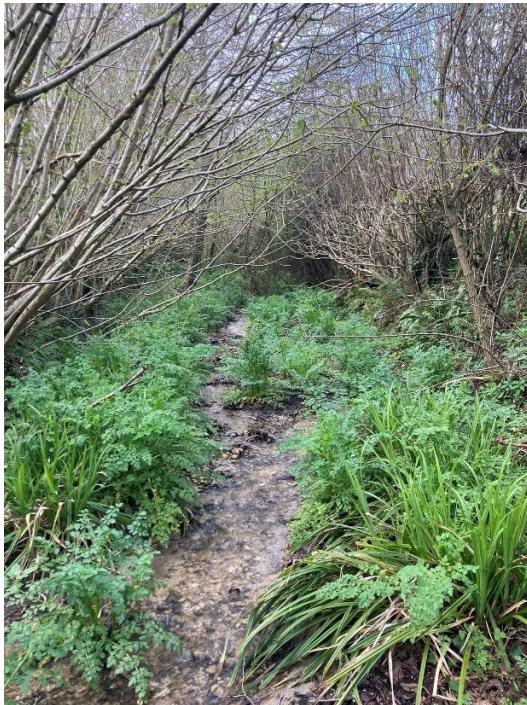
- 4.2.2 The site is linear in nature and measures approx. 590m in length.
- 4.2.3 The entrance of the bridleway from The Old Cheese House (south) is accessible but not obvious as it has become a shallow stream, lined with pendulous sedge (*Carex pendula*) and fools' watercress (*Heloscadium nodiflorum*). Hazel (*Corylus avellana*), willow sp and elder (*Sambucus nigra*) line the hedge banks that run parallel to the bridleway, crossing over the bridleway at approx. 1 – 1.5m high creating a Holloway like enclosed feature. The vegetation gets denser, lower and unpassable approx. 10 metres up the path; there are trees down and branches and vegetated growing across the bridleway.

Looking north from southern point of bridleway near Old Cheese House.

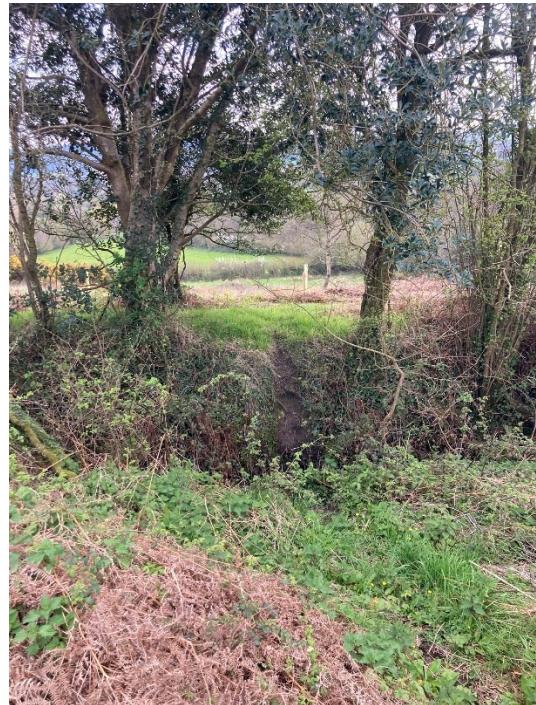
- 4.2.6 At ST4769 0289 the bridleway then 'dog legs' and travels west to east. Here it becomes a deep tree lined ditch with hazel, gorse (*Ulex europaeus*) and bracken (*Pteridium aquilinum*) on the higher banks. The stream still runs here and becomes denser and unpassable due to overgrown vegetation and low lying, fallen branches.

Looking south into ditch like east to west section of bridleway.

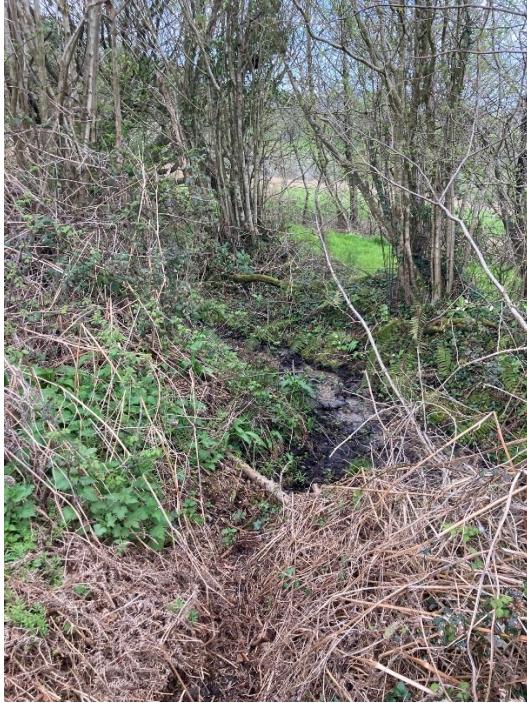
Looking north up bridleway, top half of bridleway.

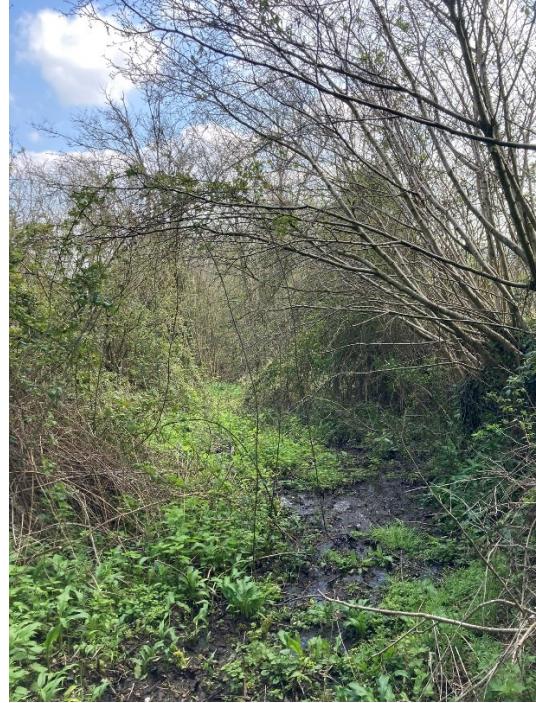
Looking south within top half of bridleway.

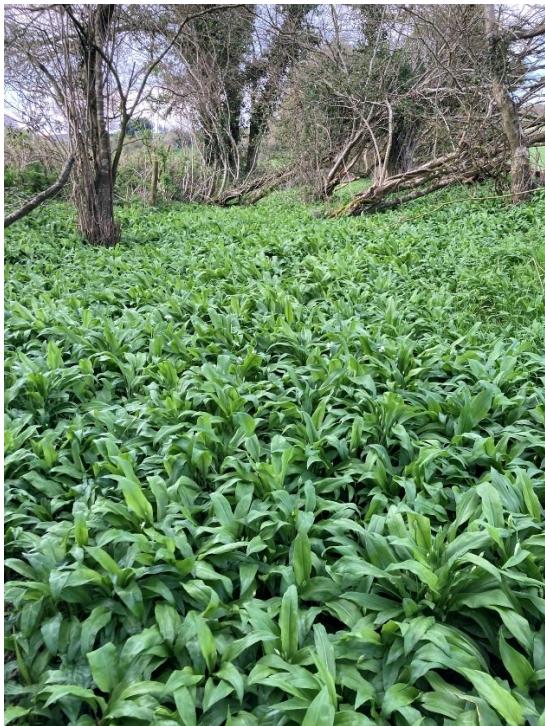
- 4.2.7 The north section at approx. ST4777 0301 is dry and much wider and open with less scrub encroachment. The hedge banks are lined with mature hazel and the ground flora is dominated by wild garlic (*Allium ursinum*). The very top section / start is blocked off by a rudimentary fence, fallen and low hanging branches and overgrown scrub.

Looking south near wider top section of bridleway.

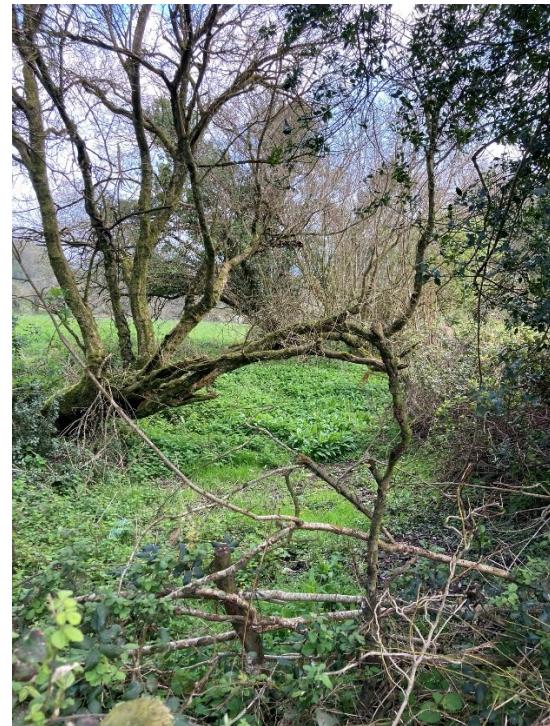
Top section fenced off near Buckingham Down Farm.
