## Observations on local Holloways in the context of Bridleway 80

(Extract from Definitive Statement for the parish of Beaminster (W21) Bridleway 80:

*478026 474048 Chantry Farm via Buckham Down to South Perrott parish boundary)*

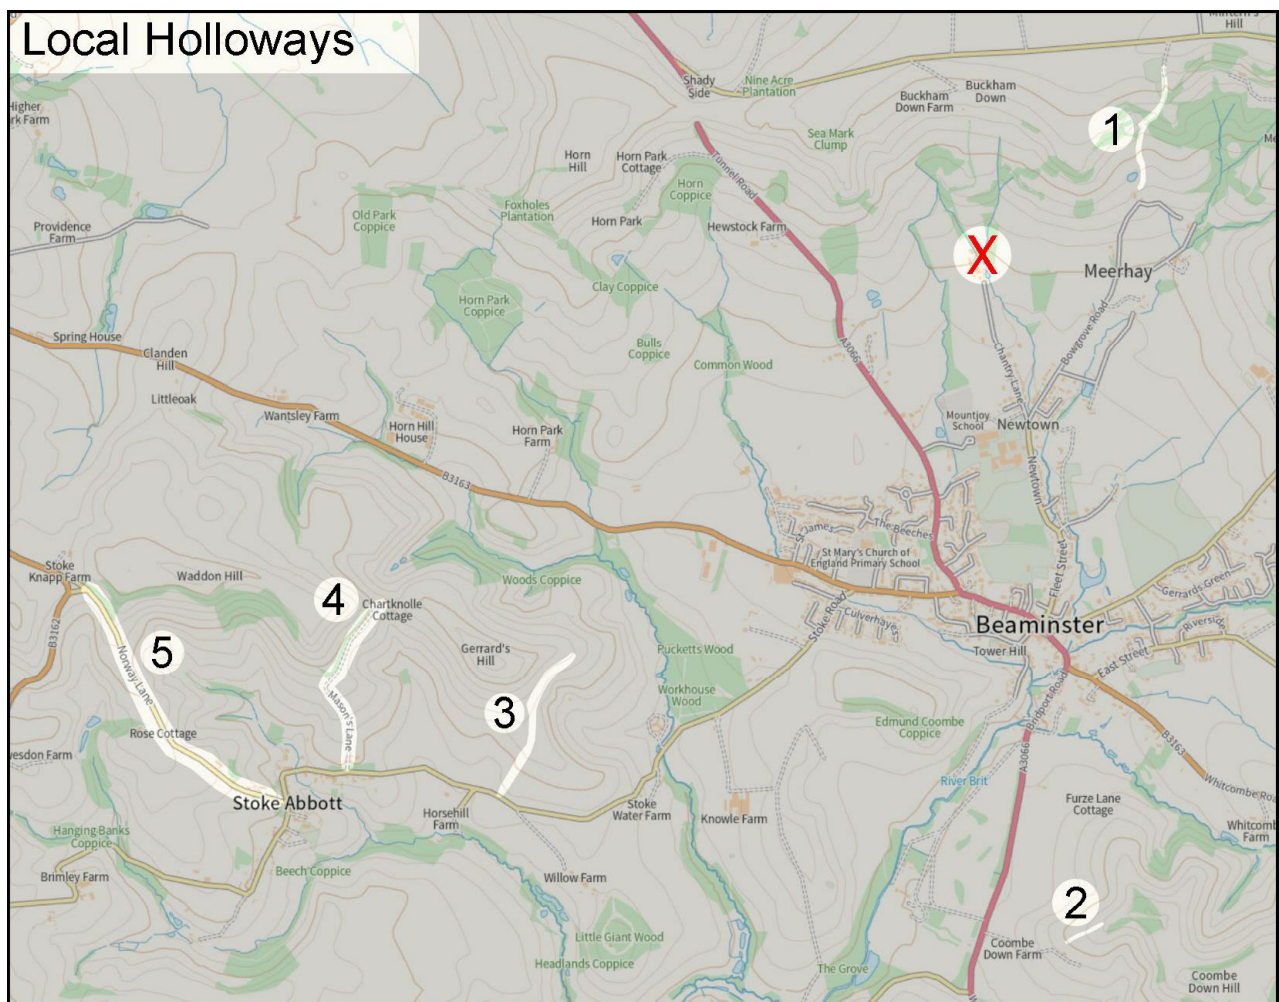
Local to Beaminster there are several good examples, annotated on the map extract below, and described thereafter, the nearest being Stinford Lane (1), 600 metres to the west of Bridleway 80. (X)

(Annotated map extract from Dorset Explorer, background map 'OS Roads')

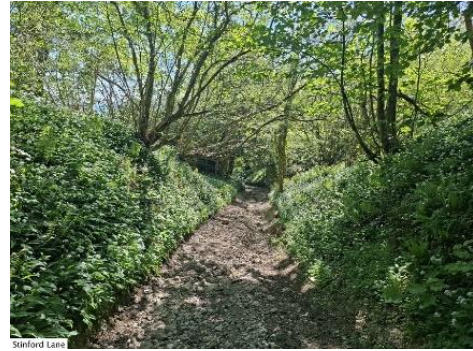
## 1. Stinford / Stintford Lane

Linking Meerhay to Beaminster Down Road.

Historically this would have been a well-used route giving access to series of chalk pits which when they fell into disuse became the town's landfill site, it was subsequently landscaped and converted into Buckham Down picnic area.

Photographs<sup>2</sup> suggest that for a few years around 1930 it was used as a hill climb section on the Motorcycling Club (MCC) London to Exeter Trial.

The harder underlying geology results in sloped banks rather than the near vertical sides that occur in the more friable sandstone.

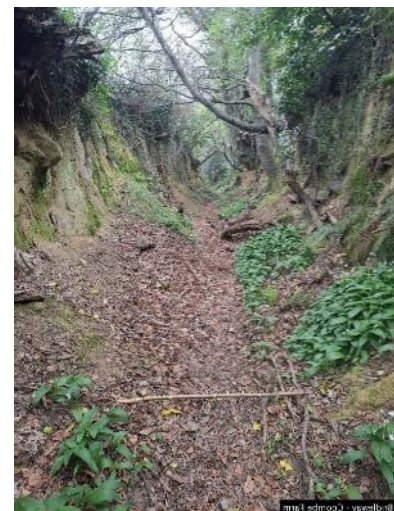
## 2. Combe Down

*The thumb-stick in the foreground of the photograph is 1.3 metres.*

A short section of Holloway on Beaminster bridleway 52 which links the A3066 to the road at Mapperton, is almost certainly an historic route. Locally the Posy Tree that used to be at the junction between the bridleway and the road at Mapperton, was said to be the meeting place on the funeral route out to South Warren Hill during the plague when victims could not be taken for burial in the churchyard at Netherbury.

Being too narrow for modern tractors the farm traffic now uses an alternate track a few metres to the south, as a result the characteristic flat bottom (Gerrard's Hill) has softened due to erosion material from the sides falling in.

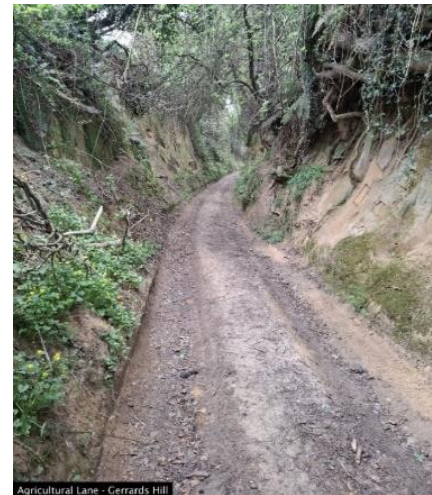
### 3. Gerrard's Hill

This “blind lane” \* unpaved track gives agricultural access to fields between adjoining landholdings. Currently of no recorded status, signage at the time of the site visit, at each end implies pedestrian access is permitted but dogs must be on leads.

\*Blind Lanes are a feature of the local landscape and appear to originate from the historic nature of the ownership in West Dorset where landholdings were often made up of non-contiguous clusters of small fields necessitating communal access routes to a field or fields that would otherwise be “landlocked”. (See Appendix F<sup>(R)</sup>)

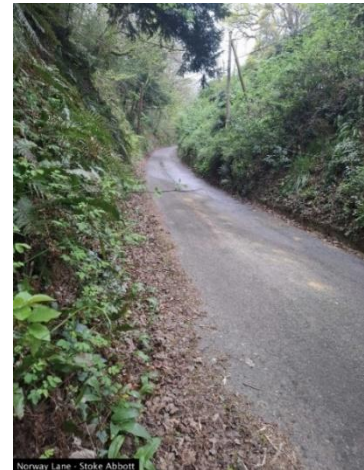
### Track between banks / hedgerows.

Superficially these common landscape features are similar to Sunken Lanes in appearance, but their origin is unrelated to the process that gives rise to Sunken Lanes. They are a man-made feature which arises because of construction of the traditional West Dorset hedgerow which comprises a hedge atop a bank. Construction starts by excavating a ditch to throw up a bank. The bank is supplemented with stone scavenged from the adjoining field. Hedging plants, e.g. Hazel, Hawthorn & Blackthorn, etc. and a few Standards (trees), e.g. Oak, Ash, etc. are planted on top. (See sketch)

The hedge is kept stock proof and in good condition by laying on a 7-10 year cycle. An unusual feature of this type of hedge is that the ditch is also maintained by throwing up any infill on to the top of the bank. When the ditch is also a drainage ditch this can result in banks growing to a considerable height as many of these hedgerows date back centuries. Custom is that, for boundary hedgerows, the ditch is dug on the owner's side. So, where a track runs between two holdings a lane between banks can be created.

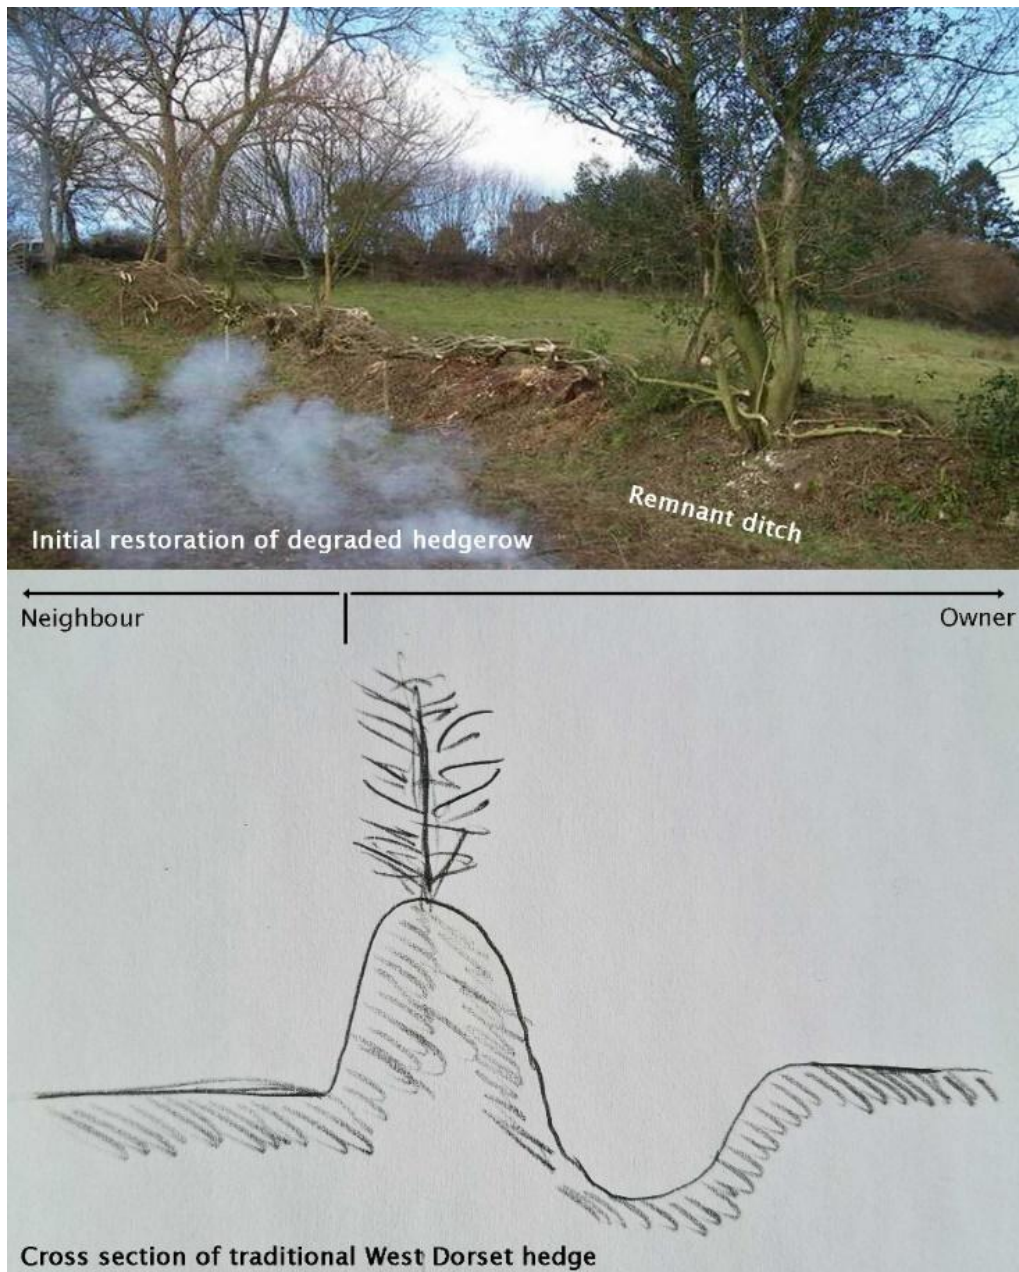
**SKETCH AND PHOTOGRAPHS [TAKEN 11<sup>TH</sup> TO 29<sup>TH</sup> APRIL 2025] BY RICHARD MEATYARD**

Maintaining these hedgerows in good order is labour intensive and as manual labour in agriculture has been replaced by mechanisation most have fallen into a state of disrepair. An unmaintained hedgerow will become a row of scrubby trees which then start dying off leaving a unevenly spaced row of trees surviving.
